Name Of Dam: LAKE MEADE DAM
Location: CITY OF SUFFOLK
Inventory Number: VA. 80013

PHASE I INSPECTION REPORT

NATIONAL DAM SAFETY PROGRAM

DEWARD M. MARTIN & ASSOCIATES
WILLIAMSBURG, VIRGINIA
AUGUST, 1979

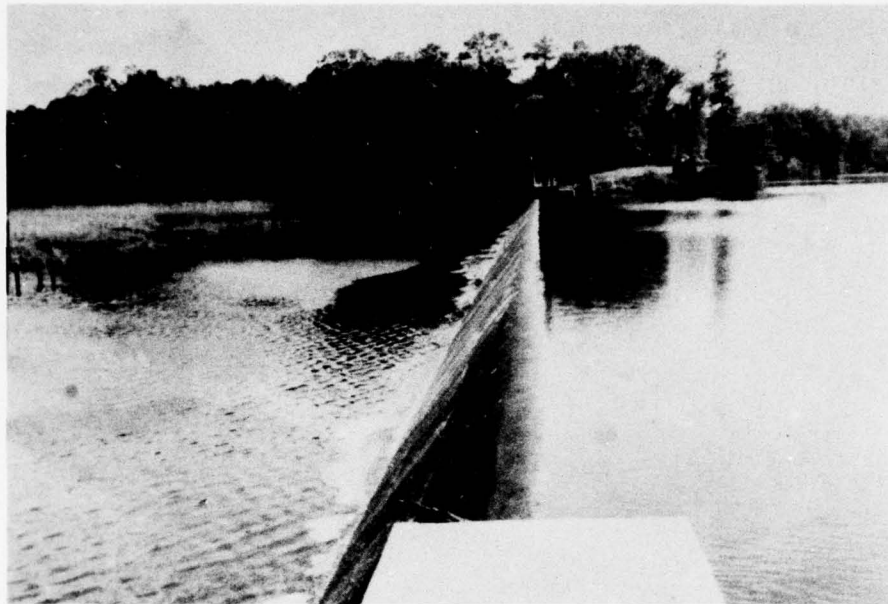
Top View of Concrete Spillway

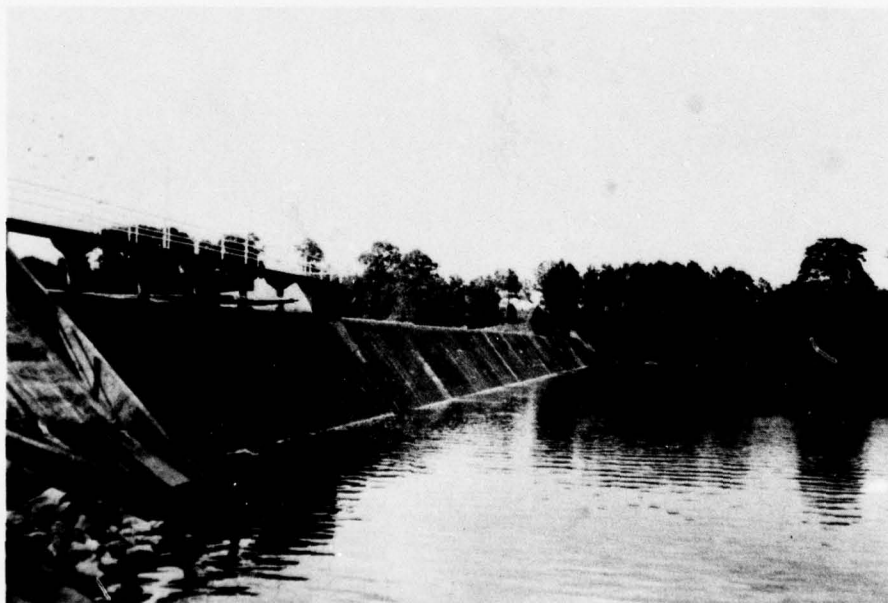
Front View of Spillway
